ARROWHEAD™

PULLEY LAGGING

Eliminate Slippage and Increase Belt Traction

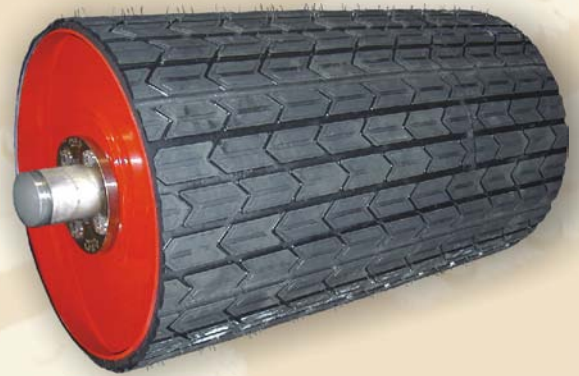
Arrowhead™ Ceramic
Pulley Lagging

Arrowhead Ceramic Pulley Lagging provides the solution when conventional rubber lagging fails to correct a belt slippage problem and/or when rubber lagging wears prematurely. Our unique Arrowhead ceramic is designed for the highest drive factors unlike the conventional square tiles.

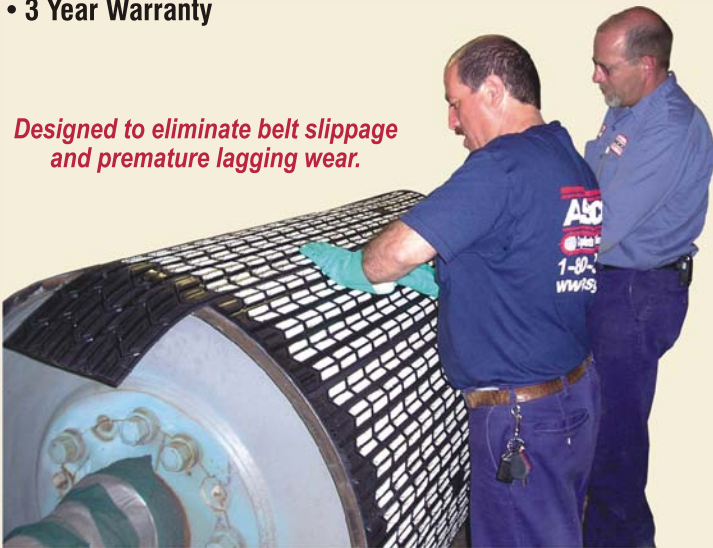
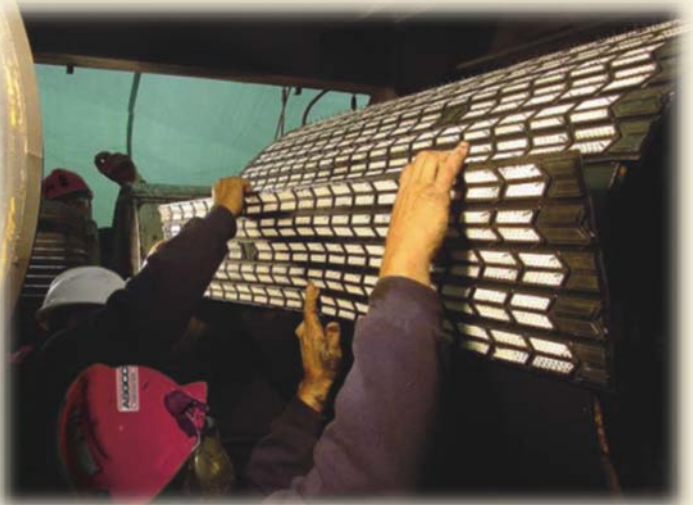
Design Features - Tiles

ISOMETRIC VIEW

- High grade aluminum oxide ceramic
- Tile fully enclosed by rubber
- Rounded corners allow for better adhesion between the rubber and the tile

Arrowhead Ceramic Tile Statistics

Arrowhead Ceramic	Arrowhead Ceramic
Total surface area of the ceramic as a percentage for the total?	50%
Height of each tile?	0.625"
Length of tile?	2"
Total thickness of ceramic?	0.32"
Percent of ceramic are raised?	27%
Height of ceramic nubs that extend above the ceramic tile?	.0625"
Diameter of ceramic nub?	0.16"
Number of nubs?	21

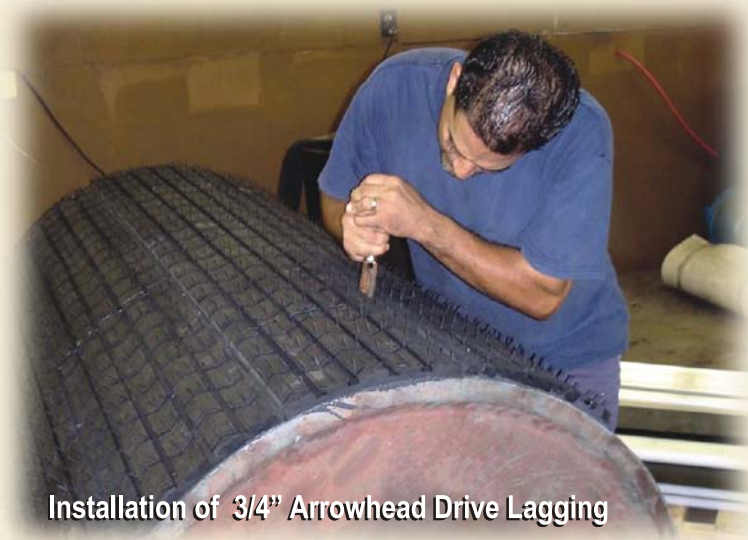
Installation of 3/4" Arrowhead Drive Lagging
