ASGCO® - Safe-Guard™ Return Idler Cage Solves Safety Issues

Industry:	Southeastern Coal Mine Surface Facility
Application:	48" Conveyor system
Product:	ASGCO® Safe-Guard™ Conveyor Return Idler Cage
Objective:	Address safety concerns for unsuspecting employees, as well as, visitors in close proximity to the overland conveyors. The measures were also put in place to bring the conveyors in compliance with MSHA and OSHA standards in regards of proper guarding.

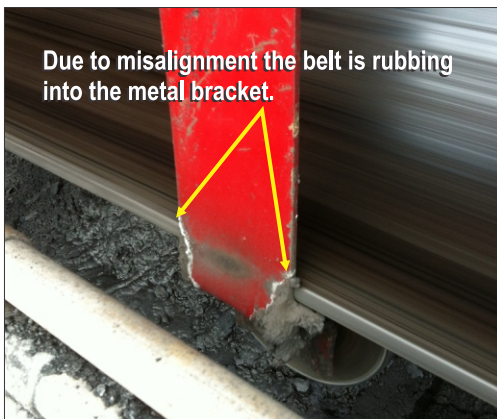
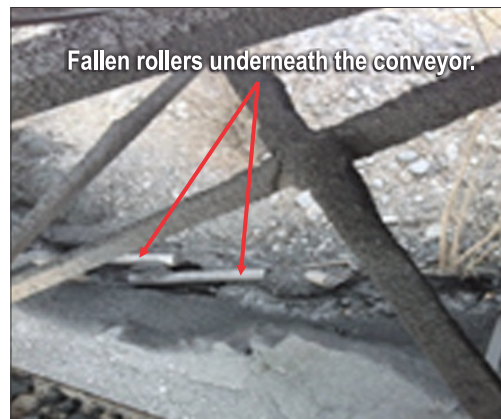
This coal mine facility faced many challenges, as all bulk handling facilities do. Overcoming obstacles in improving the safety of their conveyor system was a top priority. These type of conveyor systems have a tendency to mis-track causing the belt to cut into the hanging metal brackets holding the return roller in place. If and when the bracket gives way the large return roller will be sent tumbling downward creating a dangerous safety hazard.

After a thorough inspection of the conveyor it was pointed out that in addition to resolving the belt mis-tracking issue there needed to be further changes made to ensure safety in the workplace and to comply with OSHA and MSHA requirements. It was recommended that they install ASGCO® Safe-Guard™ Return Idler Cages to protect the return rollers and objects from falling, preventing injuries to workers and equipment.

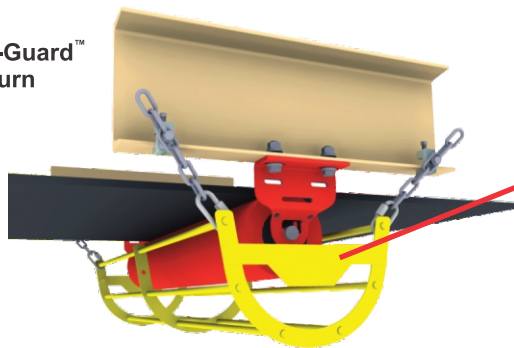
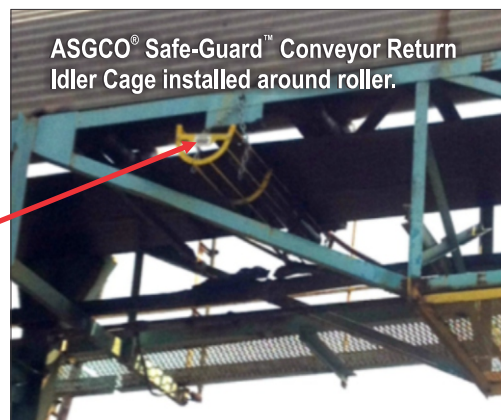
ASGCO® Safe-Guard™
Conveyor Return
Idler Cage

ASGCO® Safe-Guard™ Return Idler Cages were installed in the work areas and along the roadways to catch the return rollers if they fell. This brought the conveyors into compliance with MSHA title 30 regulations and helped the mine to reach it's safety compliance goal! The customer was very pleased with the success.
