Industry Updates and Solutions for Conveyor Material Handling Applications.

ASGCO®

Ceramic Pulley Lagging Proves to be the Answer to Wear and Slippage Problems

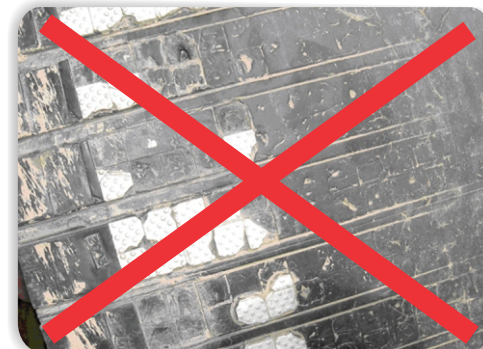
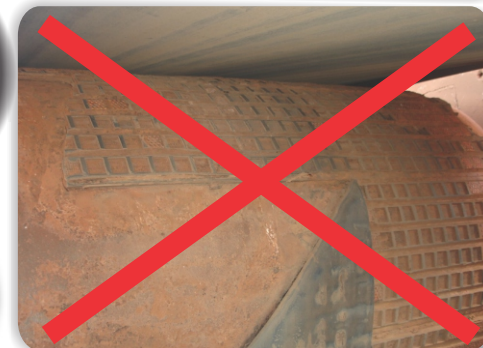
- A mining customer was getting less than a year before pulley lagging had to be changed out due to excessive wear.
- The lagging being used was a rubber lagging with square ceramic tiles pressed into the rubber, with no adhesion or rubber between the tiles to allow them to flex under high conveyor tension. The tiles would fracture, break and fly off the pulley.
- Square tile shape made it difficult to get a good bond on a 90-degree point versus a radius curve.
- Water and mud build-up in the center was forced under the tiles through a hydraulic action, further compromising the pulley lagging.

PROBLEM: Below are 2 examples of problems with ceramic lagging with the tiles not adhering to the rubber lagging as well as the rubber lagging not properly adhered to the pulley.

Arrowhead Ceramic Pulley Lagging provides the solution when conventional rubber lagging fails to correct a belt slippage problem and/or when rubber lagging wears prematurely. Our unique Arrowhead ceramic is designed for the highest drive factors, unlike conventional square tiles.

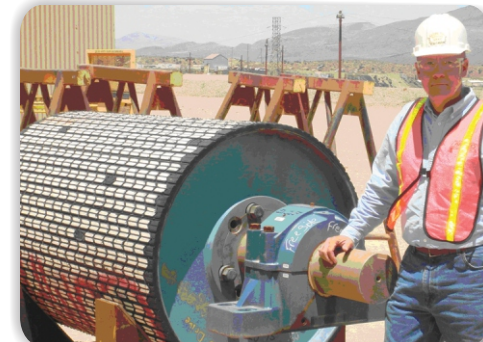
ISOMETRIC VIEW

Design Features - Tiles

- High grade aluminum oxide ceramic
- Tile fully enclosed by rubber
- Rounded corners allow for better adhesion between the rubber and the tile
