Industry Updates and Solutions for Conveyor Material Handling Applications.

Solving Material Carry-back Problems

Razor-Back Superior Secondary Belt Cleaning System

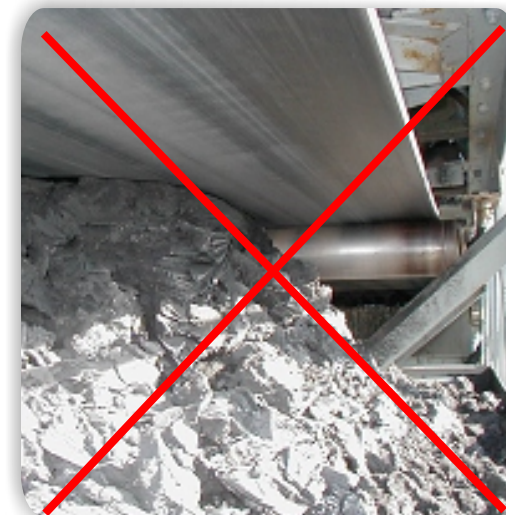
PROBLEM:

Carry-back accumulations on the return side of the conveyor belt.

A major mining operation was experiencing severe material carry-back problems along the return runs of their conveying systems. This was causing belt tracking issues due to the build-up of material on the return idlers and bend pulleys in the gravity take-up sections. It was also causing safety concerns due to the large amount of man power needed to shovel up the carry-back under each return idler as well as in the loading section of each conveyor due to the mis-tracking issues.

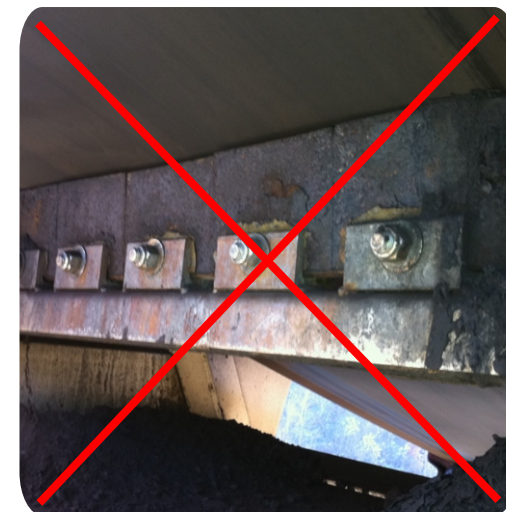
The previous cleaner removed was not tensioned and maintained. The tensioner locked up and seized.

ASGCO inspected the conveyor system and noticed the mines' belt cleaner systems were old and not being serviced properly. ASGCO installed a Razor-Back secondary belt cleaner with its patented Duo-Spring tensioning system and tungsten carbide blade cartridge system, along with a quarterly inspection/maintenance program.
