ASGCO® Tru-Trainer® Belt Tracking Idler Solves A Severe Belt Tracking Problem on FGD Scrubbing Conveyor

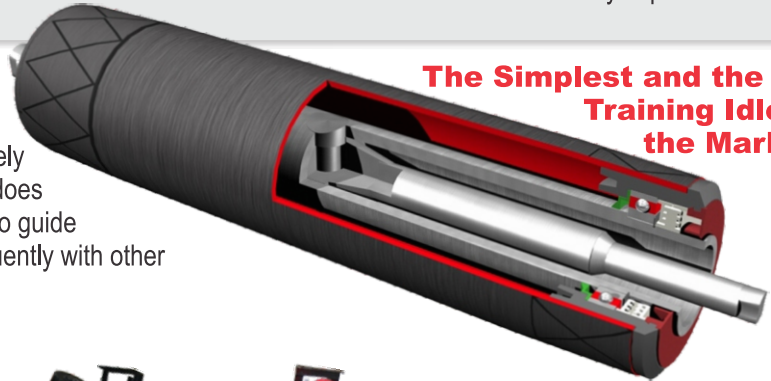
The **Tru-Trainer®** employs a patented, unique and highly effective tracking action, which is non-damaging to the belt and reacts immediately if the belt begins to drift off center. Because it does not rely on contact with the belt edge in order to guide the belt, belt edge damage, which occurs frequently with other tracking systems, is avoided.

After an ASGCO® representative surveyed the conveyor and pointed out some of the problems that was causing the belt mis-tracking. We discussed the benefits of installing two Tru-Trainer® Flat Return Idlers to help keep the conveyor belt centered on the conveyor. After installing the Tru-Trainers® the belt immediately centered itself on the conveyor system. The customer watched the performance of the Tru-Trainer® Flat Return Idlers and was extremely impressed.

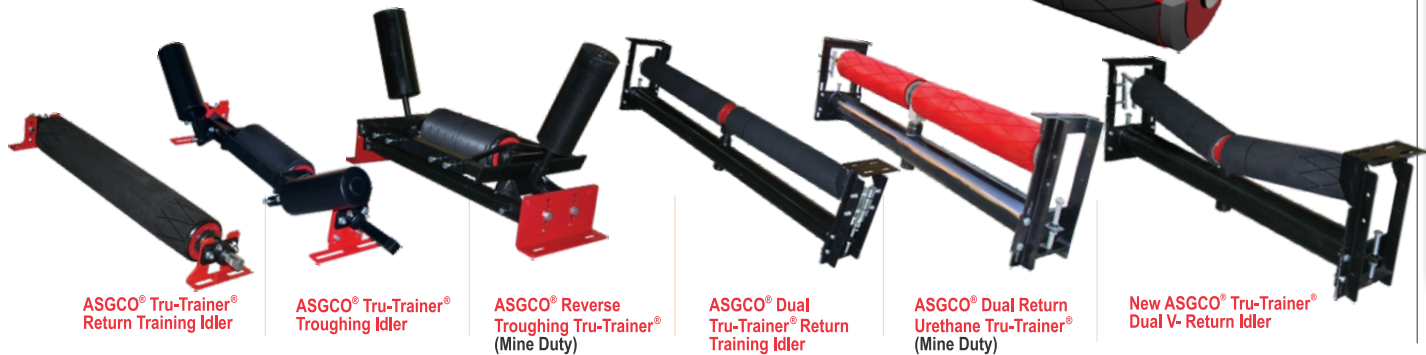
ASGCO® Tru-Trainer® Return Training Idler

ASGCO® Tru-Trainer® Troughing Idler

ASGCO® Reverse Troughing Tru-Trainer® (Mine Duty)

ASGCO® Dual Tru-Trainer® Return Training Idler

ASGCO® Dual Return Urethane Tru-Trainer® (Mine Duty)

New ASGCO® Tru-Trainer® Dual V- Return Idler

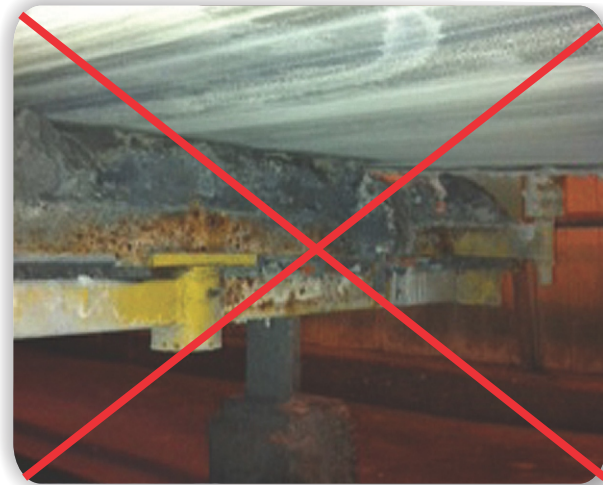
PROBLEM: Conventional return trainers locked up with material causing the belt to mistrack and rubbing steel at the head pulley.

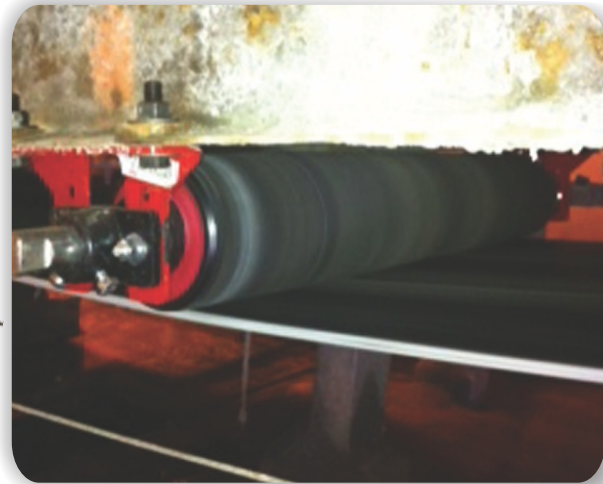
SOLUTION: ASGCO®'s Flat Return Tru-Trainer® immediately centered itself on the conveyor after installation, keeping the conveyor belt centered.
